2024 Energy Conservation & Demand Management Plan

Township of Minden Hills

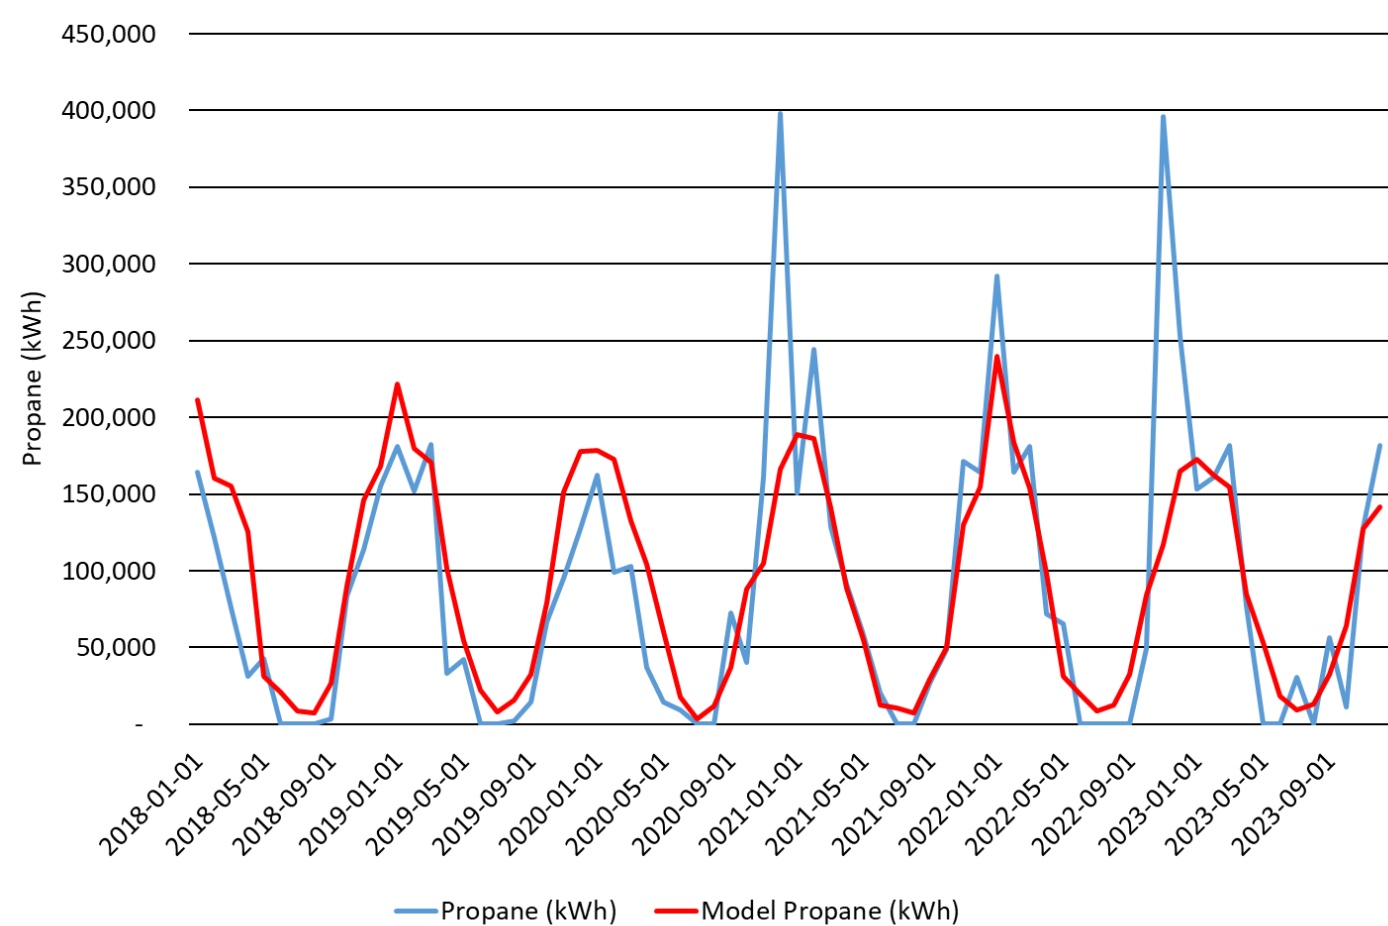
Figure 4: Minden Hills Actual Propane Consumption vs. Modelled

Despite the regression being developed using a baseline period of only 2023, the relationship appears to be applicable to prior years.

It should be noted that the large spikes in consumption that appear after the warmer months are likely due to the need to refill propane tanks. With a small but sustained usage over the summer months and then a large demand during the first cold months, it may be required to purchase a significant amount of propane at once to fill existing tanks.
